UNDERWRITERS' LABORATORIES OF CANADA

CR2632
25340(B)

Subject: Firestop System Components - Site Specific Plaza
3 x 3 ft. Fire Test

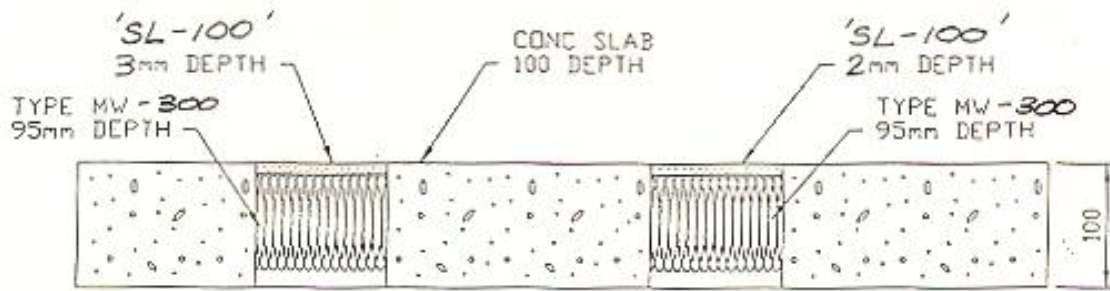
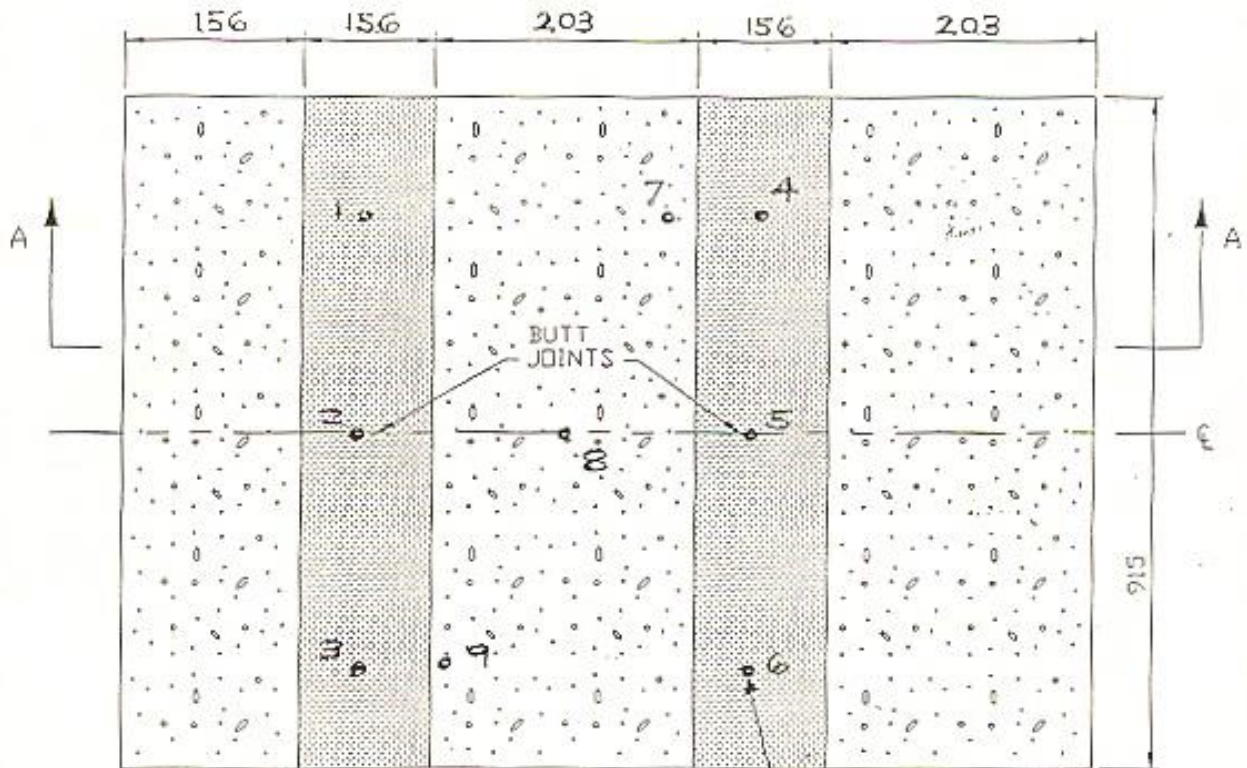
FIG 1

The test slab measured 915 mm by 915 mm, and 100 mm thick. The insulation in the assembly was installed with the grain of the material running perpendicular to the horizontal plane of the assembly. The insulation was installed in such a manner as to provide butt joints at the mid-length of each opening.

The assembly consisted of two openings each 156 mm wide. Type "NW-300" mineral wool insulation was compressed into the openings to a depth of 95 mm. The insulation was compressed to 66% its original thickness.

The insulation was recessed from the top surface of the slab by 2 mm and 3 mm at the West and East openings respectively. Type "SL-100" sealant was applied on top of the insulation to a nominal depth of 2 mm at the West opening and a nominal depth of 3 mm at the East opening, flush with the top surface of the concrete slab.

Unexposed Surface Thermocouples - Nine thermocouples and pads were constructed in accordance with BS 476: Part 20 and located on the unexposed surface of the assembly as indicated in Fig. 1.
